# Manhole Inspection Summary

Manhole # S2111\_006MH

Insp Date: **5/5/08 10:16 AM**

**Location** Address: **2623 rittenhouse rd**

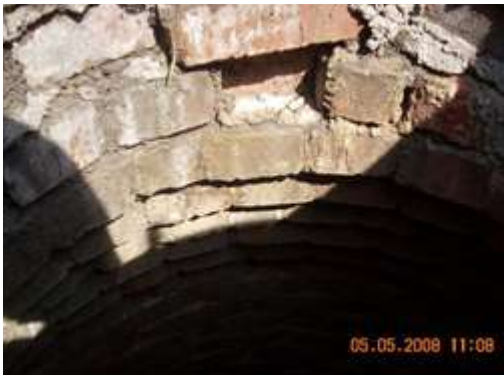
Defect 3

Condition: ☐ Sound ☐ Cracked ☐ Root Intrusion ☒ **Loose Brick** ☐ Deteriorated

loose/missing corbel brick

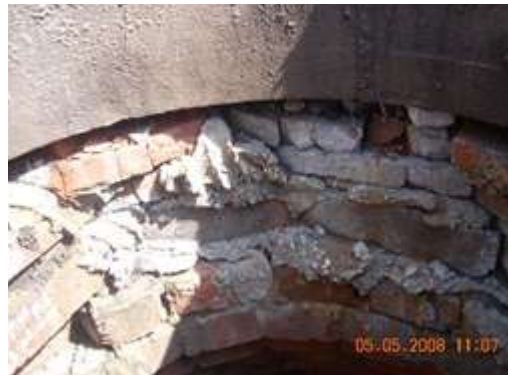
Defect 2

Condition: ☐ Sound ☐ Cracked ☐ Root Intrusion ☐ Loose Brick ☒ **Deteriorated**

deteriorated chimney

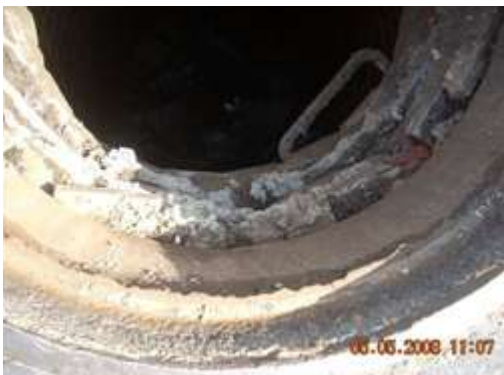
Defect 1

Offset: **2** (in.)

frame offset

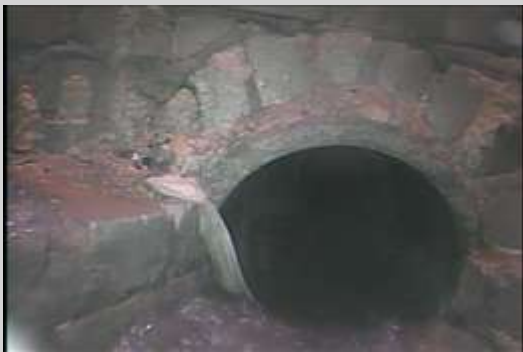
12 O'Clock Outflow

Pipe Height: **10.8** (in.) Rod and Bar (Angled)  
Pipe Material: **Clay** ☐ Pipe Lined  
Invert Depth: **12.90** (ft.) Flow Characteristics: **Fast**  
Deposits: ☐ None ☐ Mud ☒ **Sludge** ☐ Debris ☐ Grease  
Silt Depth: **1** (in.) Deposits Extent: **Light**  
Infiltration: **None** Pipe Seal Cond: **Sound**
